Manhole Inspection Summary

Manhole # S3500_042MH

Location Address: **2342 CAMP ST**

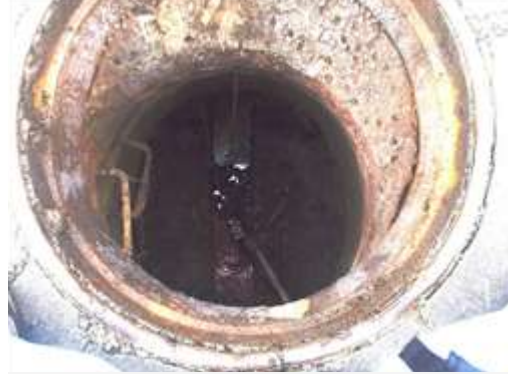
Top View

Corroded steps. Evidence of surcharge - Bench debris. Channel debris.

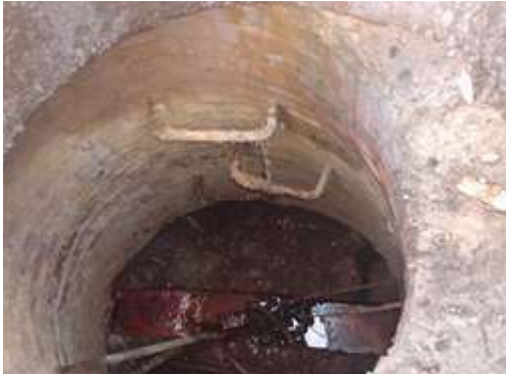
Defect

Frame Offset: **12** (in.) Condition: ☐ Sound ☐ Cracked ☒ **Leaks**

Condition: ☐ Sound ☐ Cracked ☐ Root Intrusion ☐ Loose Brick ☒ **Deteriorated**

Infiltration: ☐ None ☒ **Joint** ☐ Cracks ☐ Mortar ☐ Roots ☒ **Wall**

Frame leaks. Adjustment deterioration and infiltration. Corbel and Barrel infiltration.

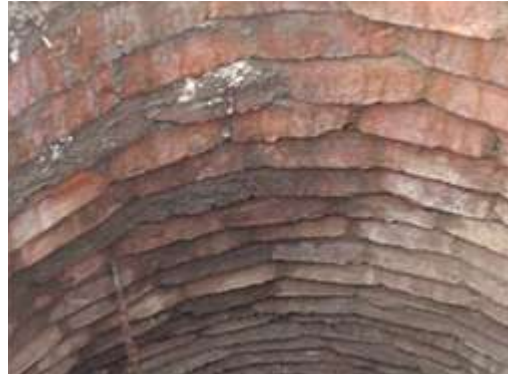
Defect

Infiltration: ☐ None ☐ Joint ☐ Cracks ☐ Mortar ☐ Roots ☒ **Wall**

Corbel and Barrel infiltration.

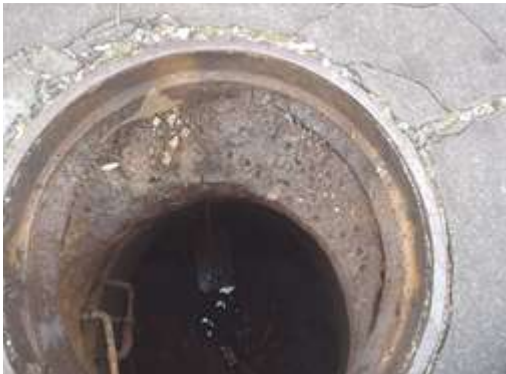
Defect

Comments **12" OF FRAME OFFSET.**

Frame leaks. Frame offset. Adjustment infiltration.

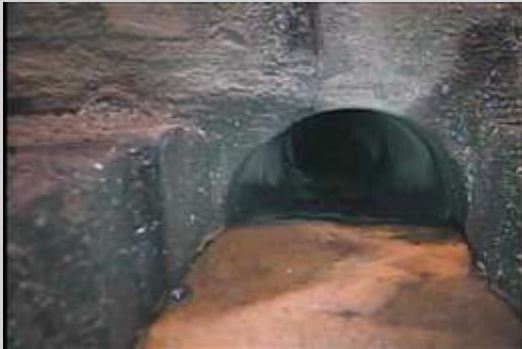
8 in. Circular Gravity Sewer Pipe Out @ 12 O'Clock

Deposits: ☐ None ☒ **Mud** ☐ Sludge ☒ **Debris** ☐ Grease

Silt Depth: **3** (in.) Deposits Extent: **Medium**

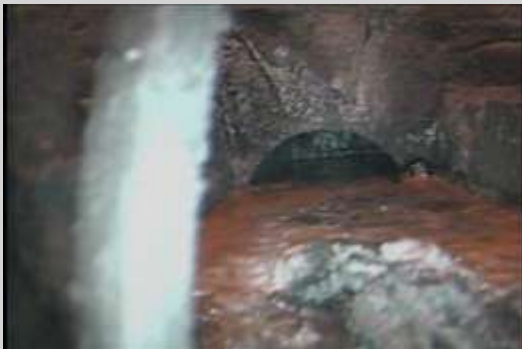
8 in. Circular Gravity Sewer Pipe In @ 6 O'Clock

Deposits: ☐ None ☒ **Mud** ☐ Sludge ☒ **Debris** ☐ Grease

Silt Depth: **4** (in.) Deposits Extent: **Heavy**
